**Final Report to the Teton County Commissioners:  
Rehabilitation of the Evapotranspiration Final Cover at the  
Teton County Municipal Solid Waste Landfill**

RegTech, Inc

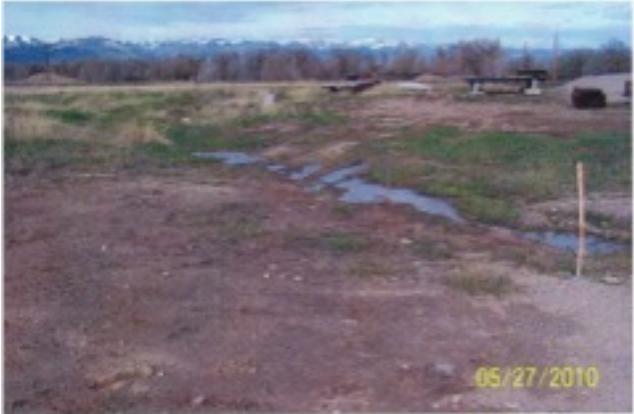
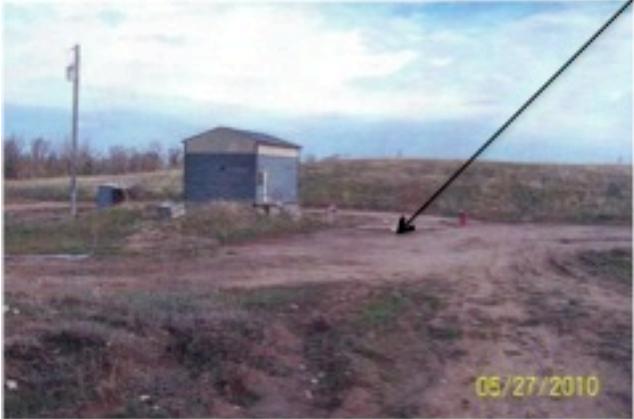
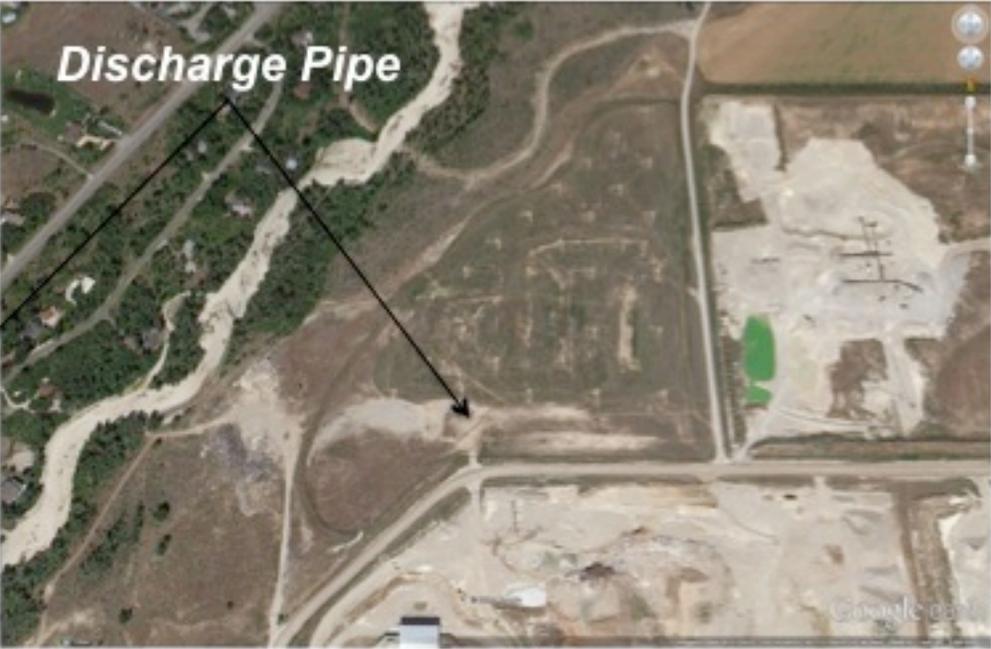
**Figure 1.** Areal view (Google Earth image) of the Teton County Municipal Solid Waste Landfill and location of the discharge pipe (to the right). On the left Photos (Courtesy of Teton County) of the location of the discharge pipe and surface water discharge.

original position. The pipe is not a requirement of Landfill Closure. Since that time the pipe has begun to discharge water to the surface below the landfill cover Figure 1. The characteristics of the pipe—its length, elevation at its upper end, its placement relative to the waste material—are unknown.

The orientation of the discharge pipe, relative to the waste material in the landfill is unknown. The discharge pipe is not a requirement of Landfill Closure nor does it offer any valuable insight to the performance of the landfill or its cover in the future. It has provided speculative evidence that *leachate* is being generated from the landfill area around the discharge pipe.

During upcoming rehabilitation of the ET landfill cover, remove the discharge pipe and document its dimensions, attitude and location.
